NBSIR 75-788

Evaluation of the Fire Hazard in a Mobile Home Resulting from an Ignition on the Kitchen Range

Edward K. Budnick and David P. Klein

Interim Report

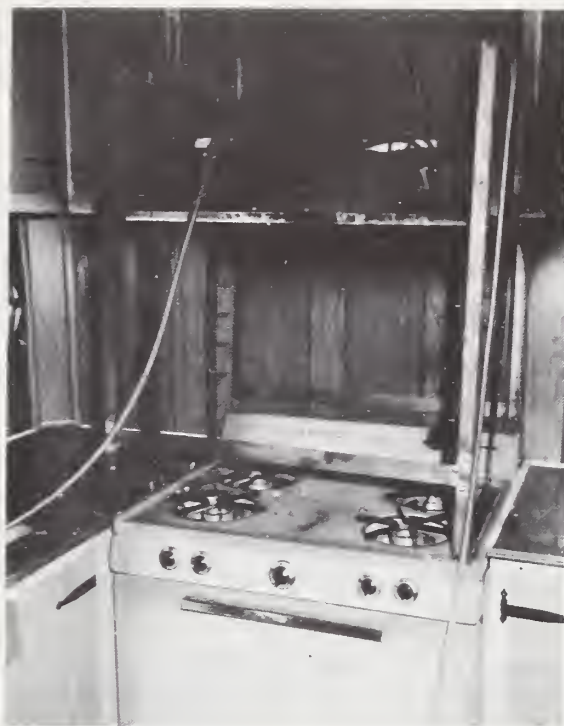
Figure 5. Test Apparatus for Measuring Incident Heat Flux

The equipment included an asbestos sample 24.5 in x 27 in (62.2 cm x 68.9 cm) with 4 holes provided for installation of heat flux transducers to measure radiant and convective heat directly above the range burners (see fig. 5).

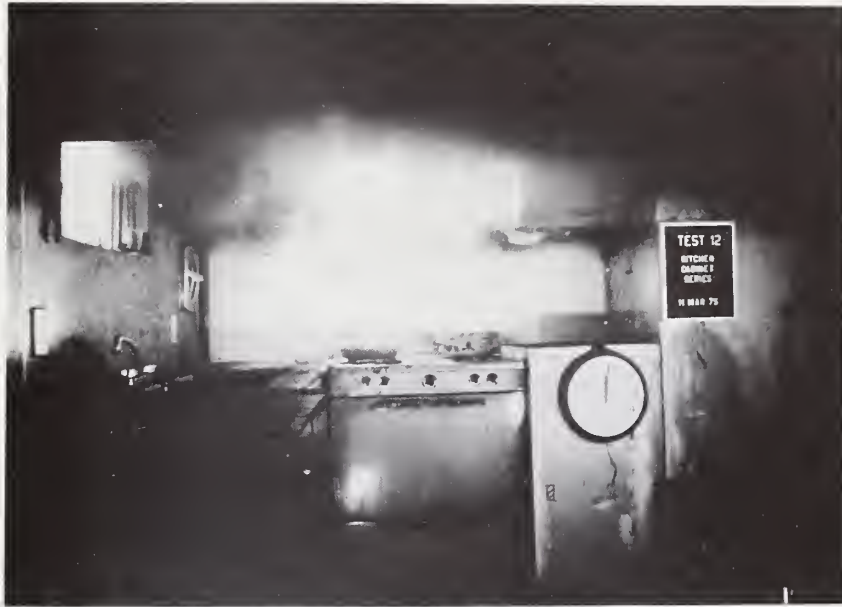
Figure 8. Illustrates the Extent of Involvement of a Cabinet Assembly Without a Metal Range Hood (Time: 2 min-20 s)

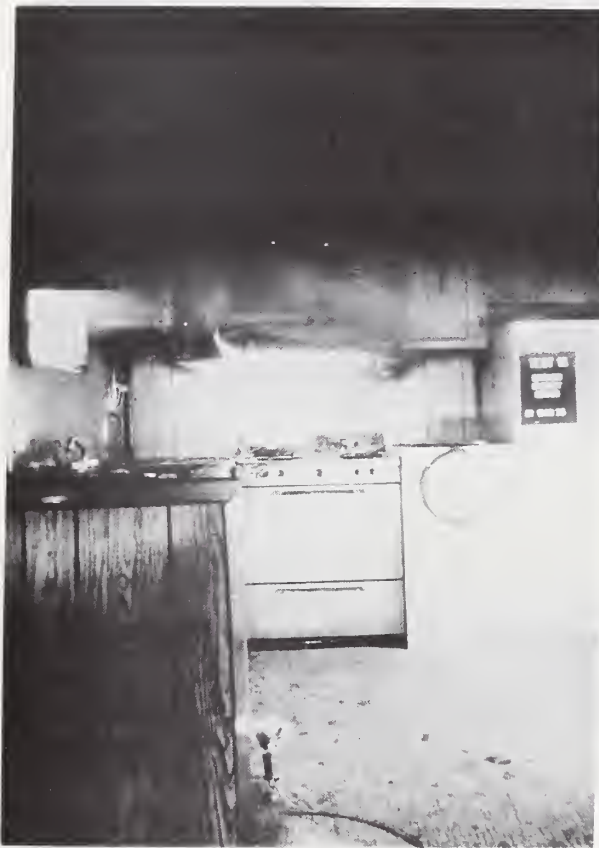
Figure 9. Illustrates the Extent of Involvement of a Cabinet With a Metal Range Hood (Time: 2 min-20 s)

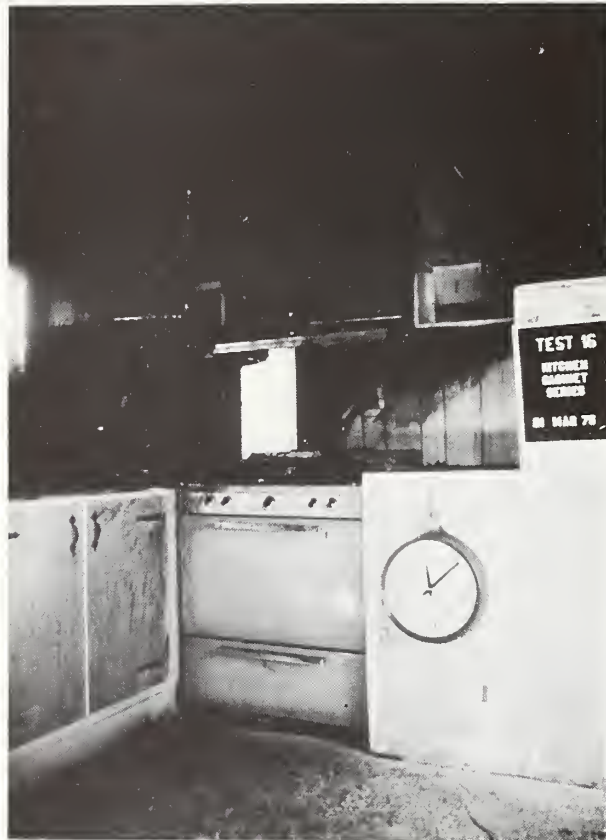
Figure 10. Illustrates Burn-Through of the Back Wall in Test 16; the Wall was Constructed of 5/32-inch Printed Lauan Plywood

In Tests 1, 5, and 16, the use of 5/32-inch lauan plywood with an ASTM E-84 flame spread rating of Class C (76-200) resulted in burn-through to the adjacent bedroom (see fig. 10) exposing the electrical wiring in the wall partition as well as providing the flames with a vertical path into the ceiling cavity. The Class C material also allowed lateral propagation, including flame impingement on the refrigerator. Observations from Test 16 indicate that impingement on the refrigerator occurred at 1 min-35 s. This test was, however, somewhat more dramatic than Tests 1 and 5, and it appears as though the low relative humidity in Test 16 may have contributed to this. The time recorded for Test 1 was 4 minutes, which was under more normal environmental conditions.

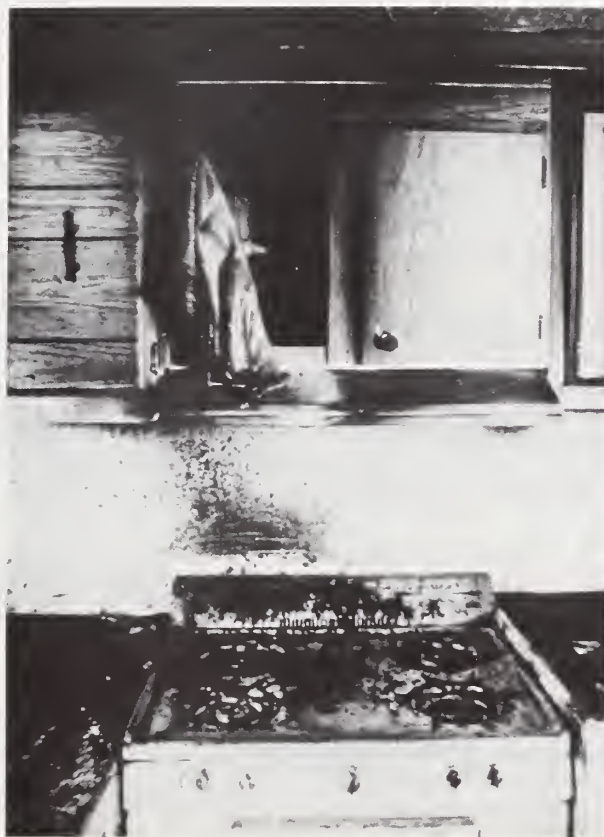
Figure 11. Illustrates the Performance of a Molded Polystyrene Cabinet Door (left) and a Printed Particle Board Cabinet Door (right) to a Test Fire. In this Test a Metal Range Hood was Installed.

In all three tests in which polystyrene doors were tested, the door assemblies failed (see fig. 11), resulting in greater temperatures inside the cabinet and ignition of the countertops and the vinyl flooring due to direct exposure from the melting and burning cabinet door debris. However, as the doors melted and dripped away from the cabinet assemblies, ceiling temperatures were reduced. Greater quantities of smoke and irritants were noted by observers during the tests which included the molded polystyrene doors than during the other tests.
